# WEATHERING

# ABOUT ACCOYA®

V08.15 – these guidelines have been written for professionals wishing to use Accoya to create beautiful, reliable and highly durable end products. Should you require further information or have any comments about this document, please contact Accsys through www.accoya.com.

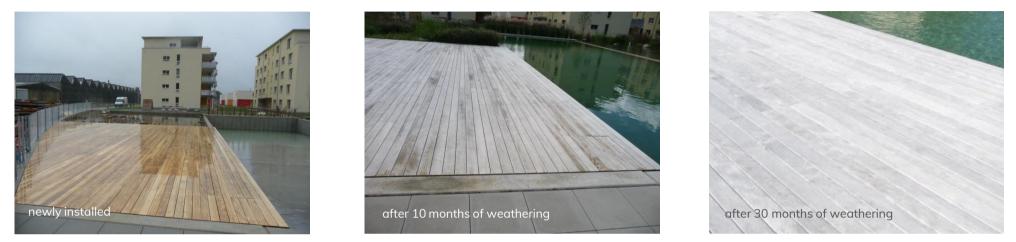
#### PUBLIC POOL DECKING, OESINGEN, SWITZERLAND

This deck in Oesingen was photographed when newly installed (left), after 10 months (middle) and after 30 months of weathering (right).

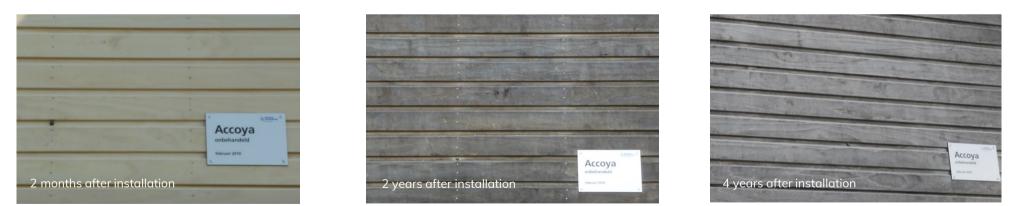
#### OFFICE CLADDING, VROOMS-HOOP, THE NETHERLANDS

A part of the South facing façade was cladded with Accoya in April 2010, with no maintenance since. The pictures below (left to right) show this cladding in July 2010, 2012 and 2014.

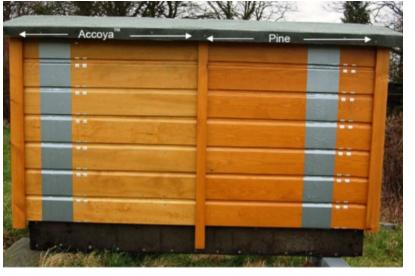
Test set-up at the start of the exposure in February 2008

The translucent stain system consisted of a pig-mented primer with two topcoats. The cladding boards used were machined to a rebated shiplap profile with the upper edge rounded to a radius of  $\pm$  10mm.

After nearly 7 years of south-facing exposure in a challenging environment the Accoya boards were found to be in a largely serviceable condition with only 2 of the 7 cladding boards showing discerni-ble evidence of stress in the form of mould or mil-dew growth.

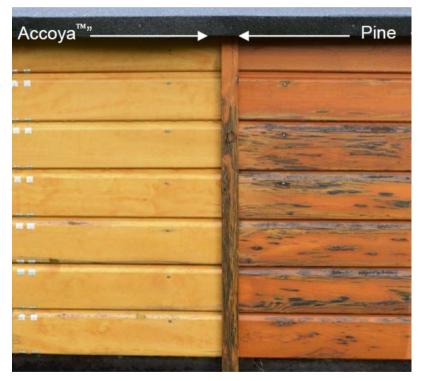
Test set-up after 7 years of exposure in January 2015

The pine boards were found to have developed severe bluestain disfigurement leading to patchy and discontinuous disfigurement beneath the coating.
